**Historic Drainage Analysis
LCP Chemicals Inc. Superfund Site
Linden, New Jersey**

**HISTORIC DRAINAGE ANALYSIS
LCP CHEMICALS INC. SUPERFUND SITE
LINDEN, NEW JERSEY**

**ISP Environmental Services Inc.
1361 Alps Road
Wayne, New Jersey 07470**

**Brown and Caldwell
110 Commerce Drive
Allendale, New Jersey 07401**

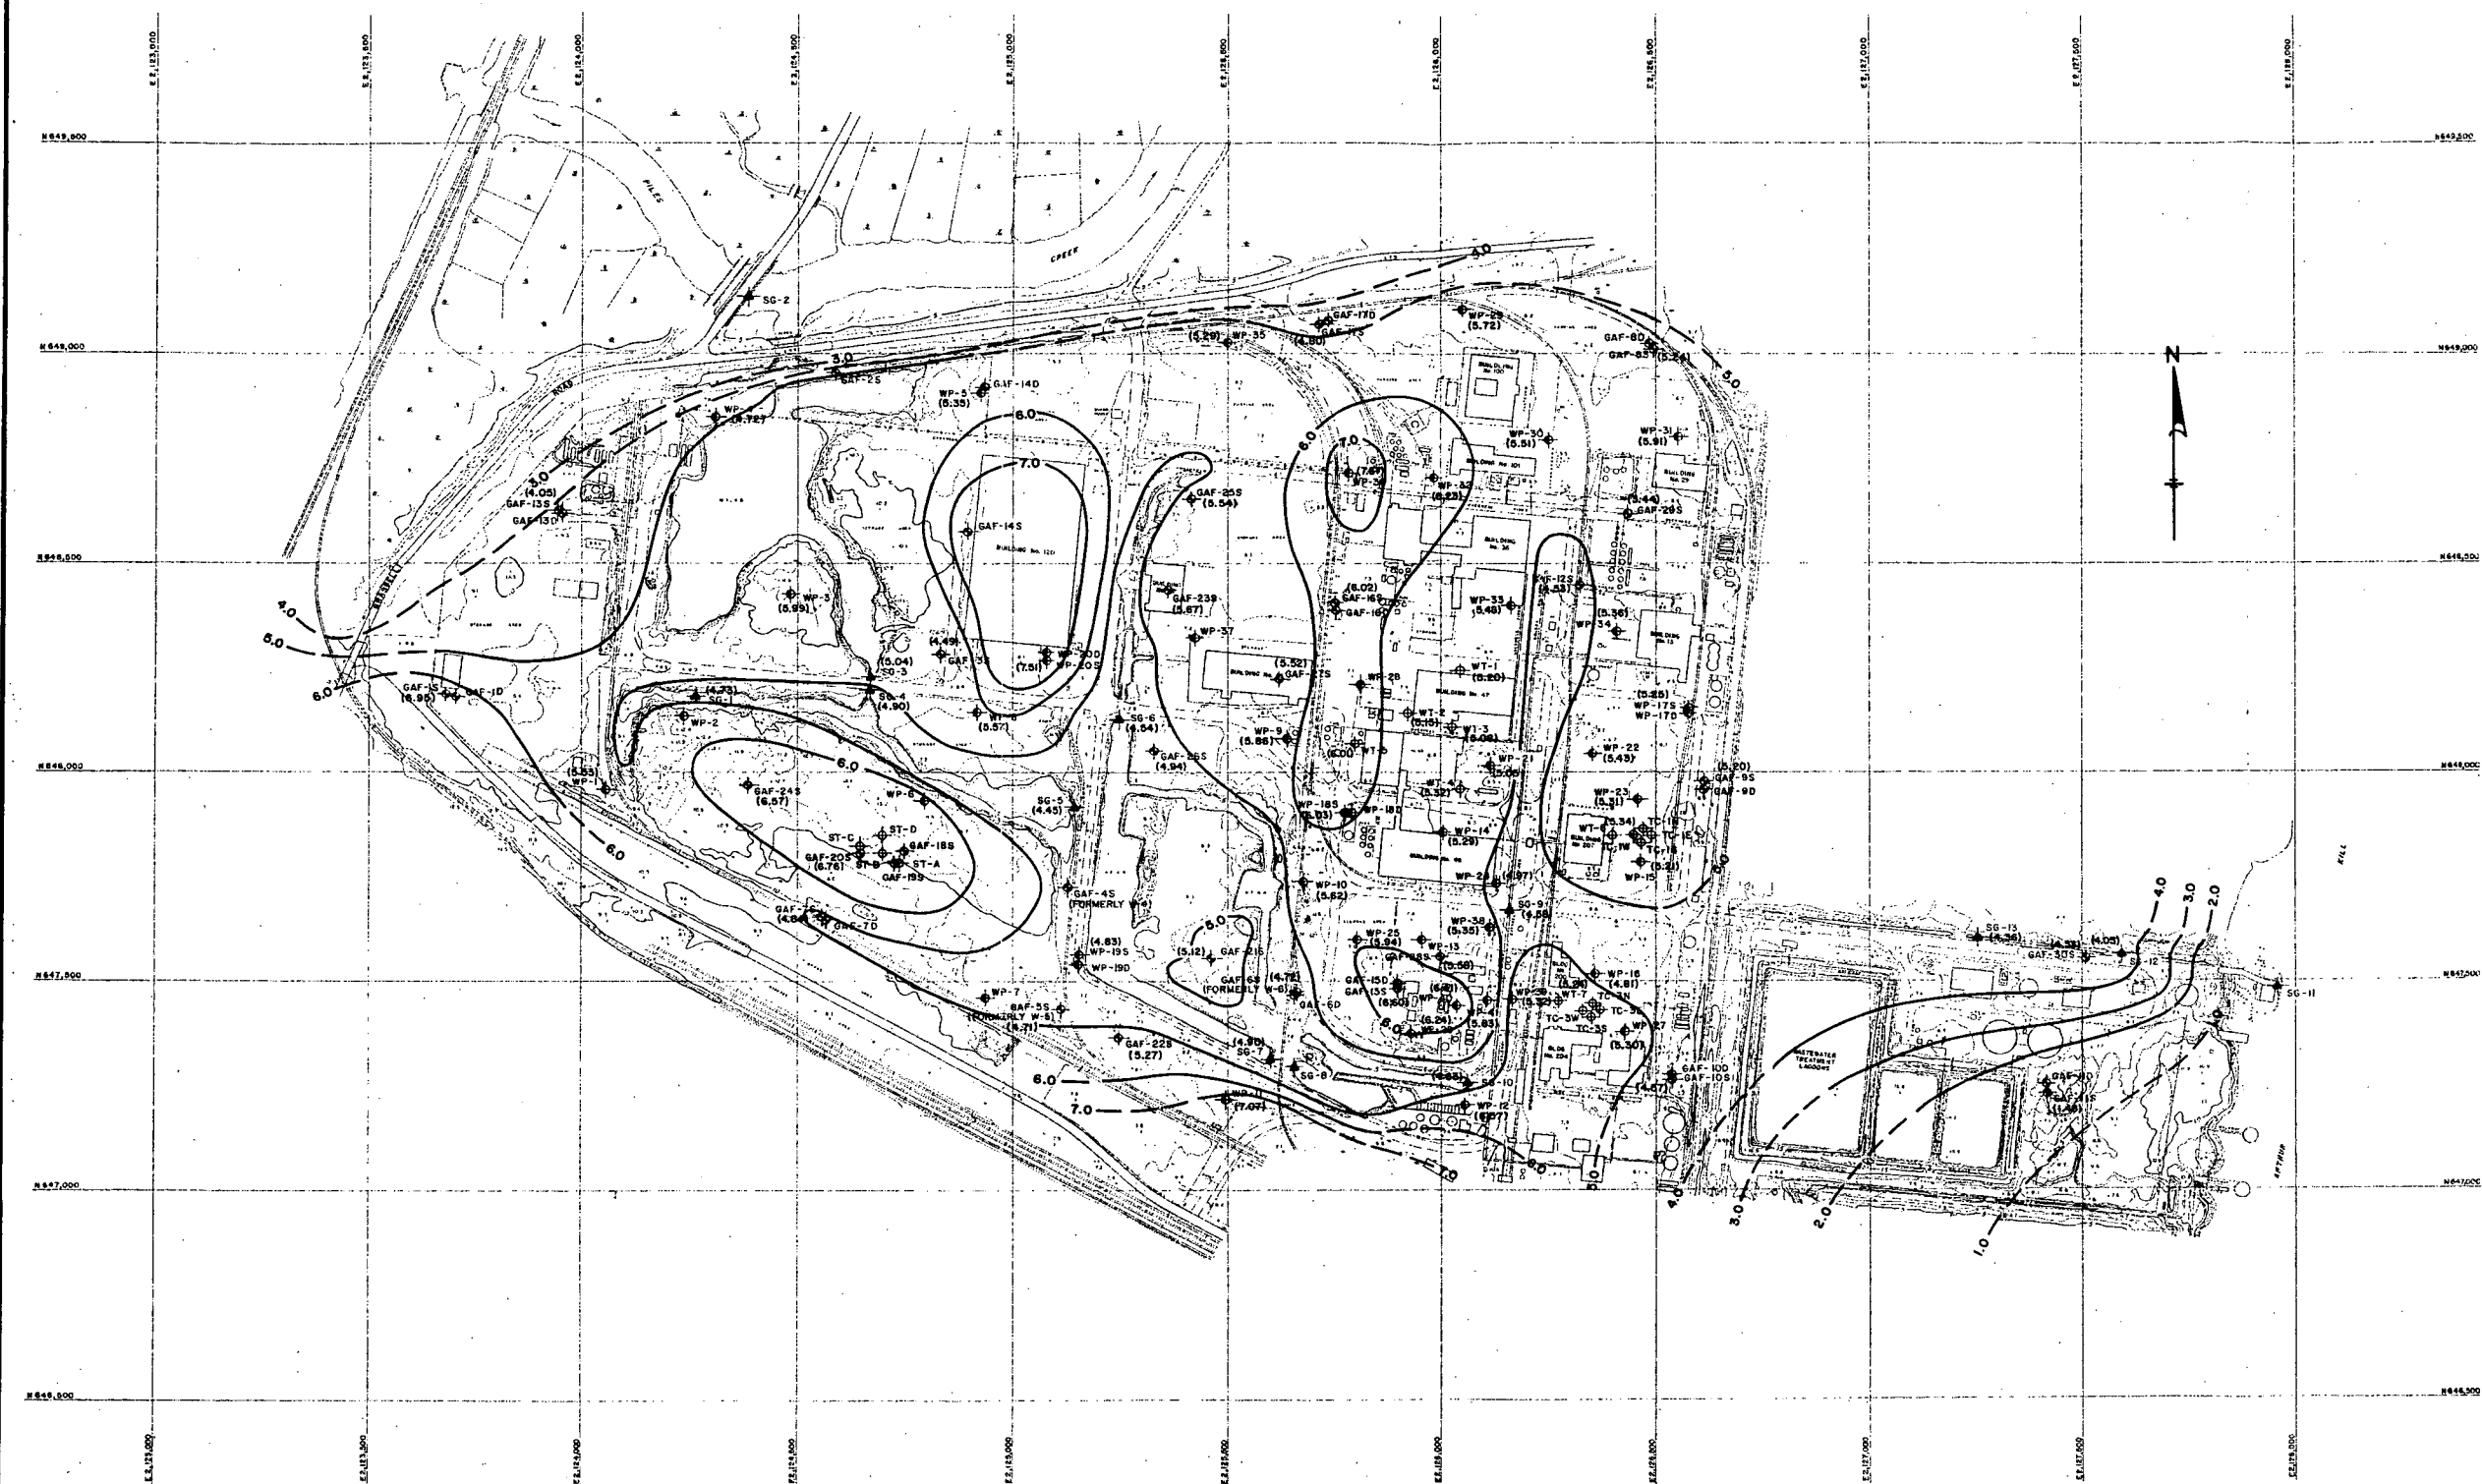
NOTE:
STAFF GAUGE MEASUREMENTS COLLECTED FROM TIDAL SURFACE WATER BODIES DO NOT CORRELATE WITH GROUNDWATER ELEVATIONS WHICH ARE NOT EFFECTED BY THE TIDE.

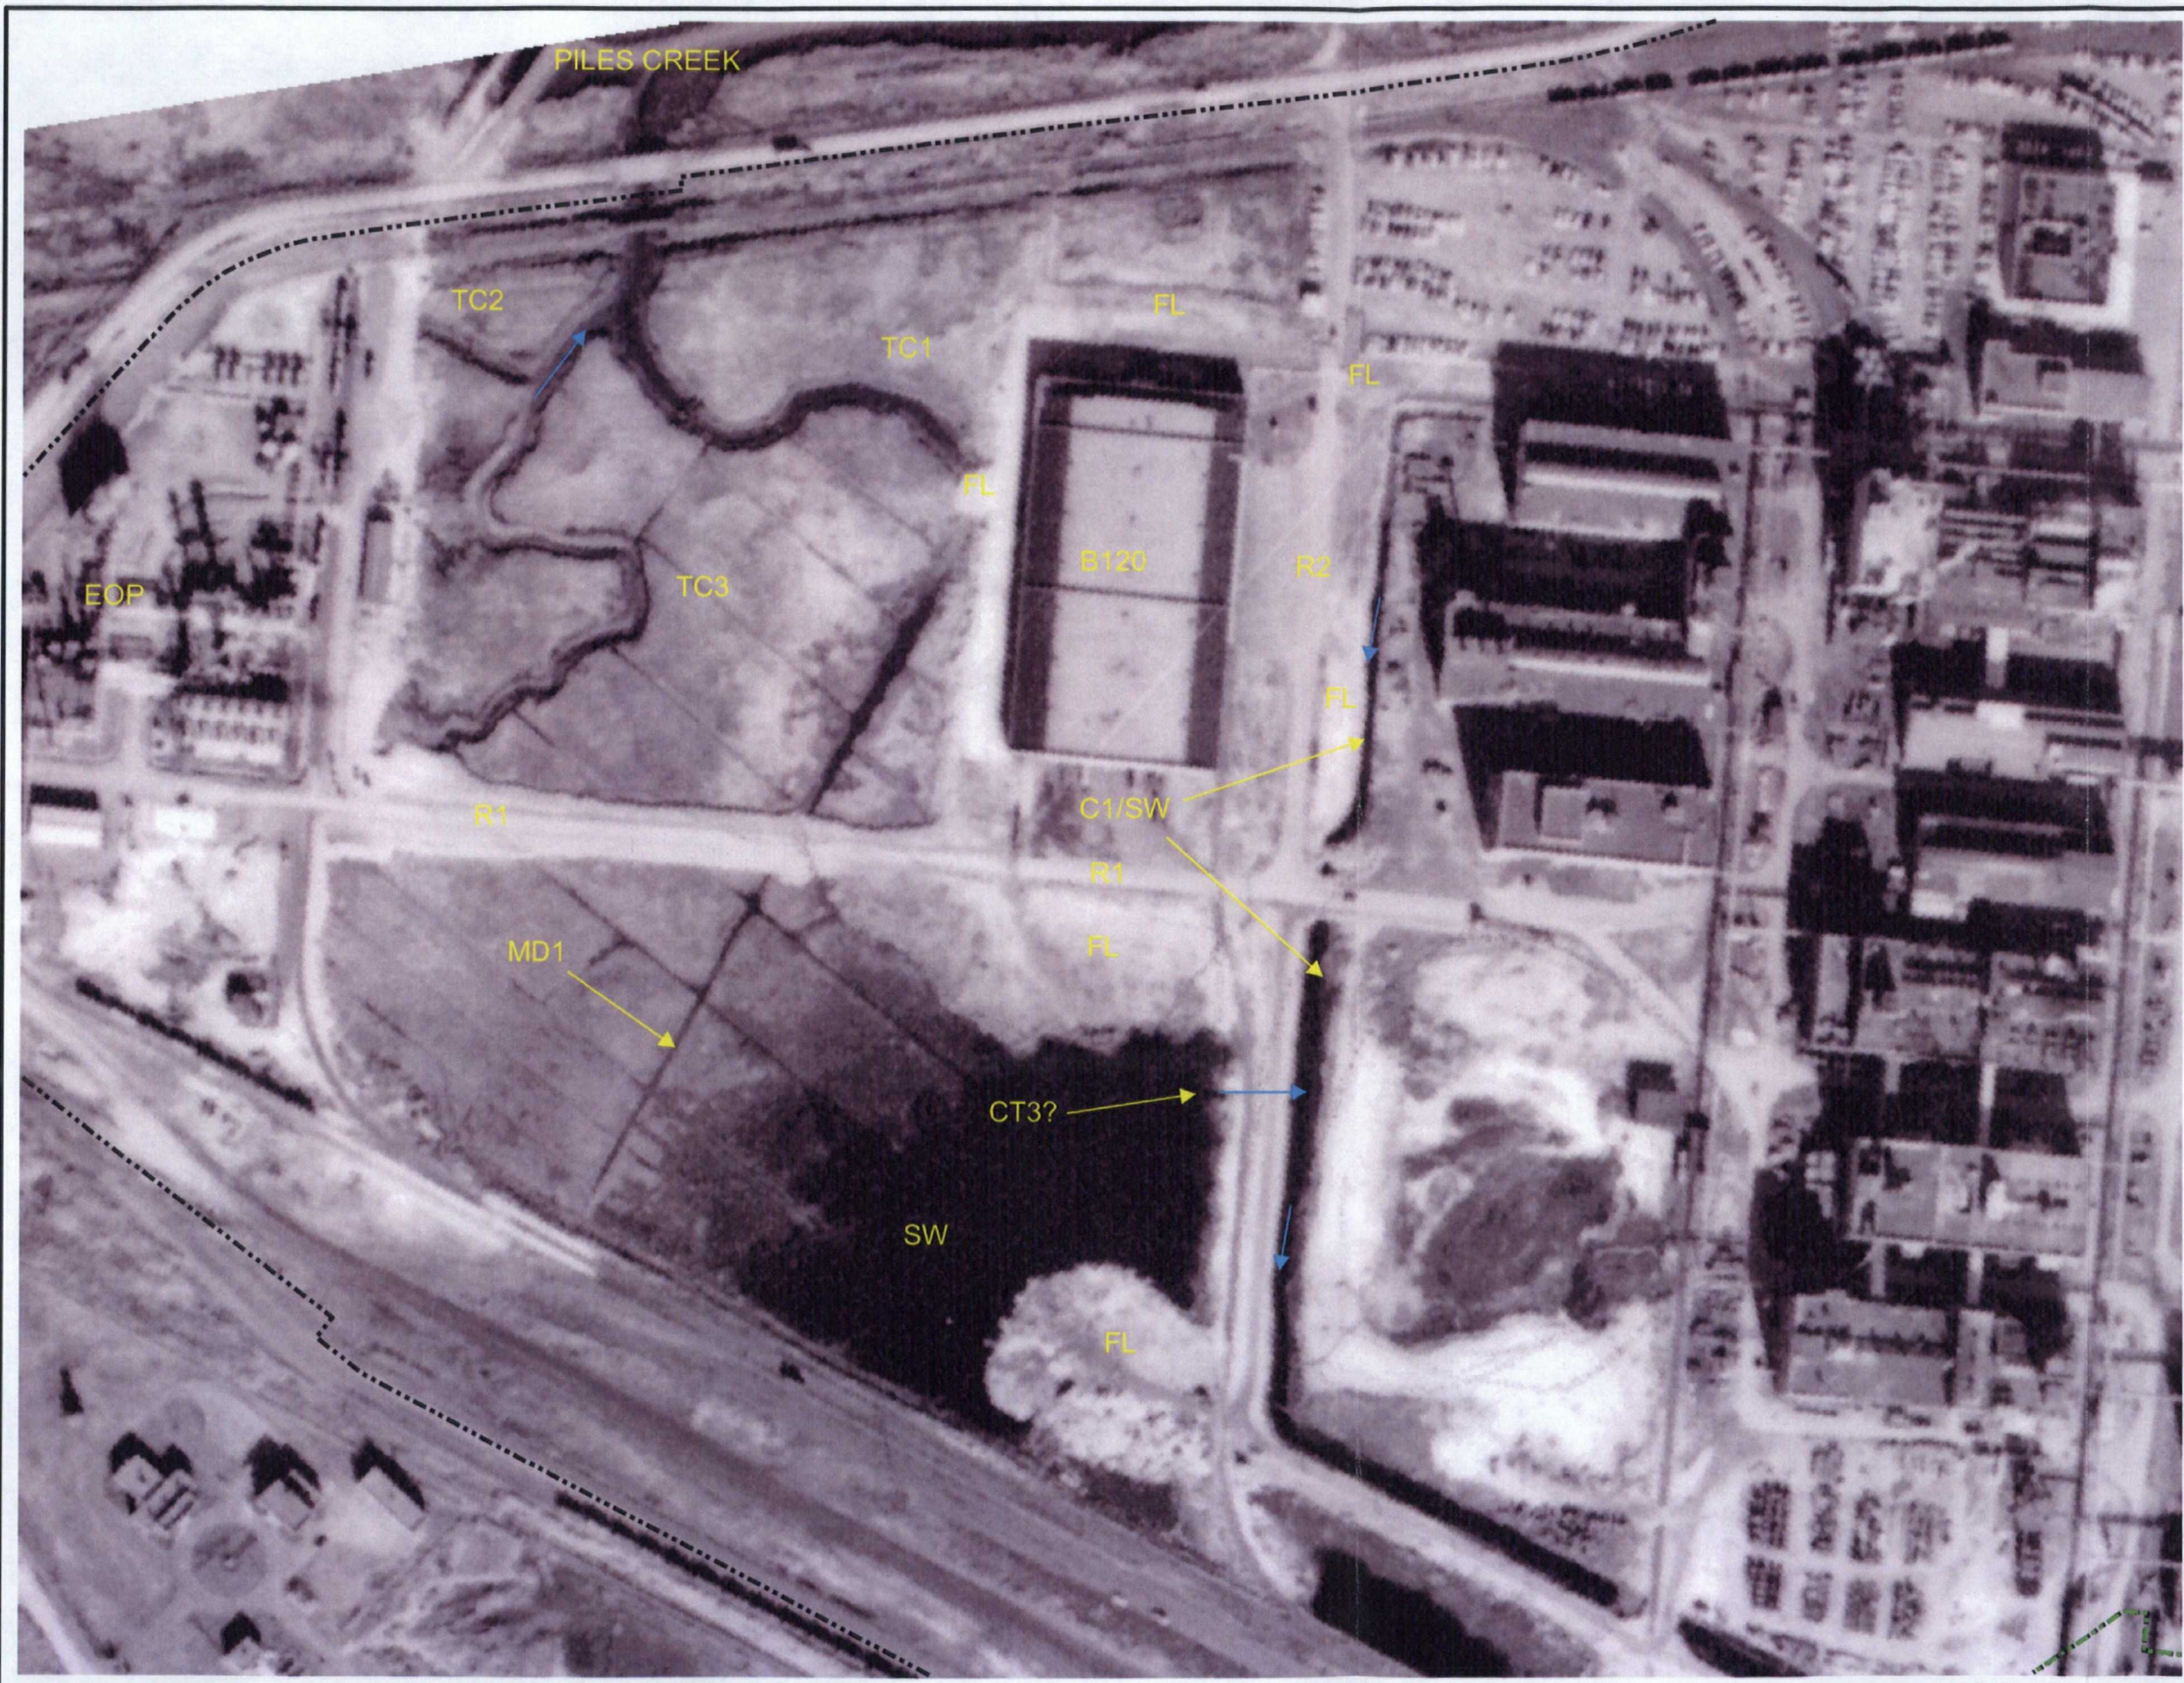
FIGURE 2-6
ISP LINDEN SITE
AND LCP SITE
MAY 16, 1954
LCP Chemicals, Inc. Superfund Site
Linden, New Jersey

Each of the features described above on the close-up view is depicted on the large-view map on Figure 2-6.

As shown in the large-view photograph, the location of South Branch Creek is observed in the southeast corner of the ISP-ESI site where it flows across the center of the future LCP site. South Branch Creek connects and discharges to the Arthur Kill at a point on the ISP-ESI site, located approximately 750 feet north of the current discharge point. A box culvert (CT) is under construction along the southern loop of South Branch Creek.

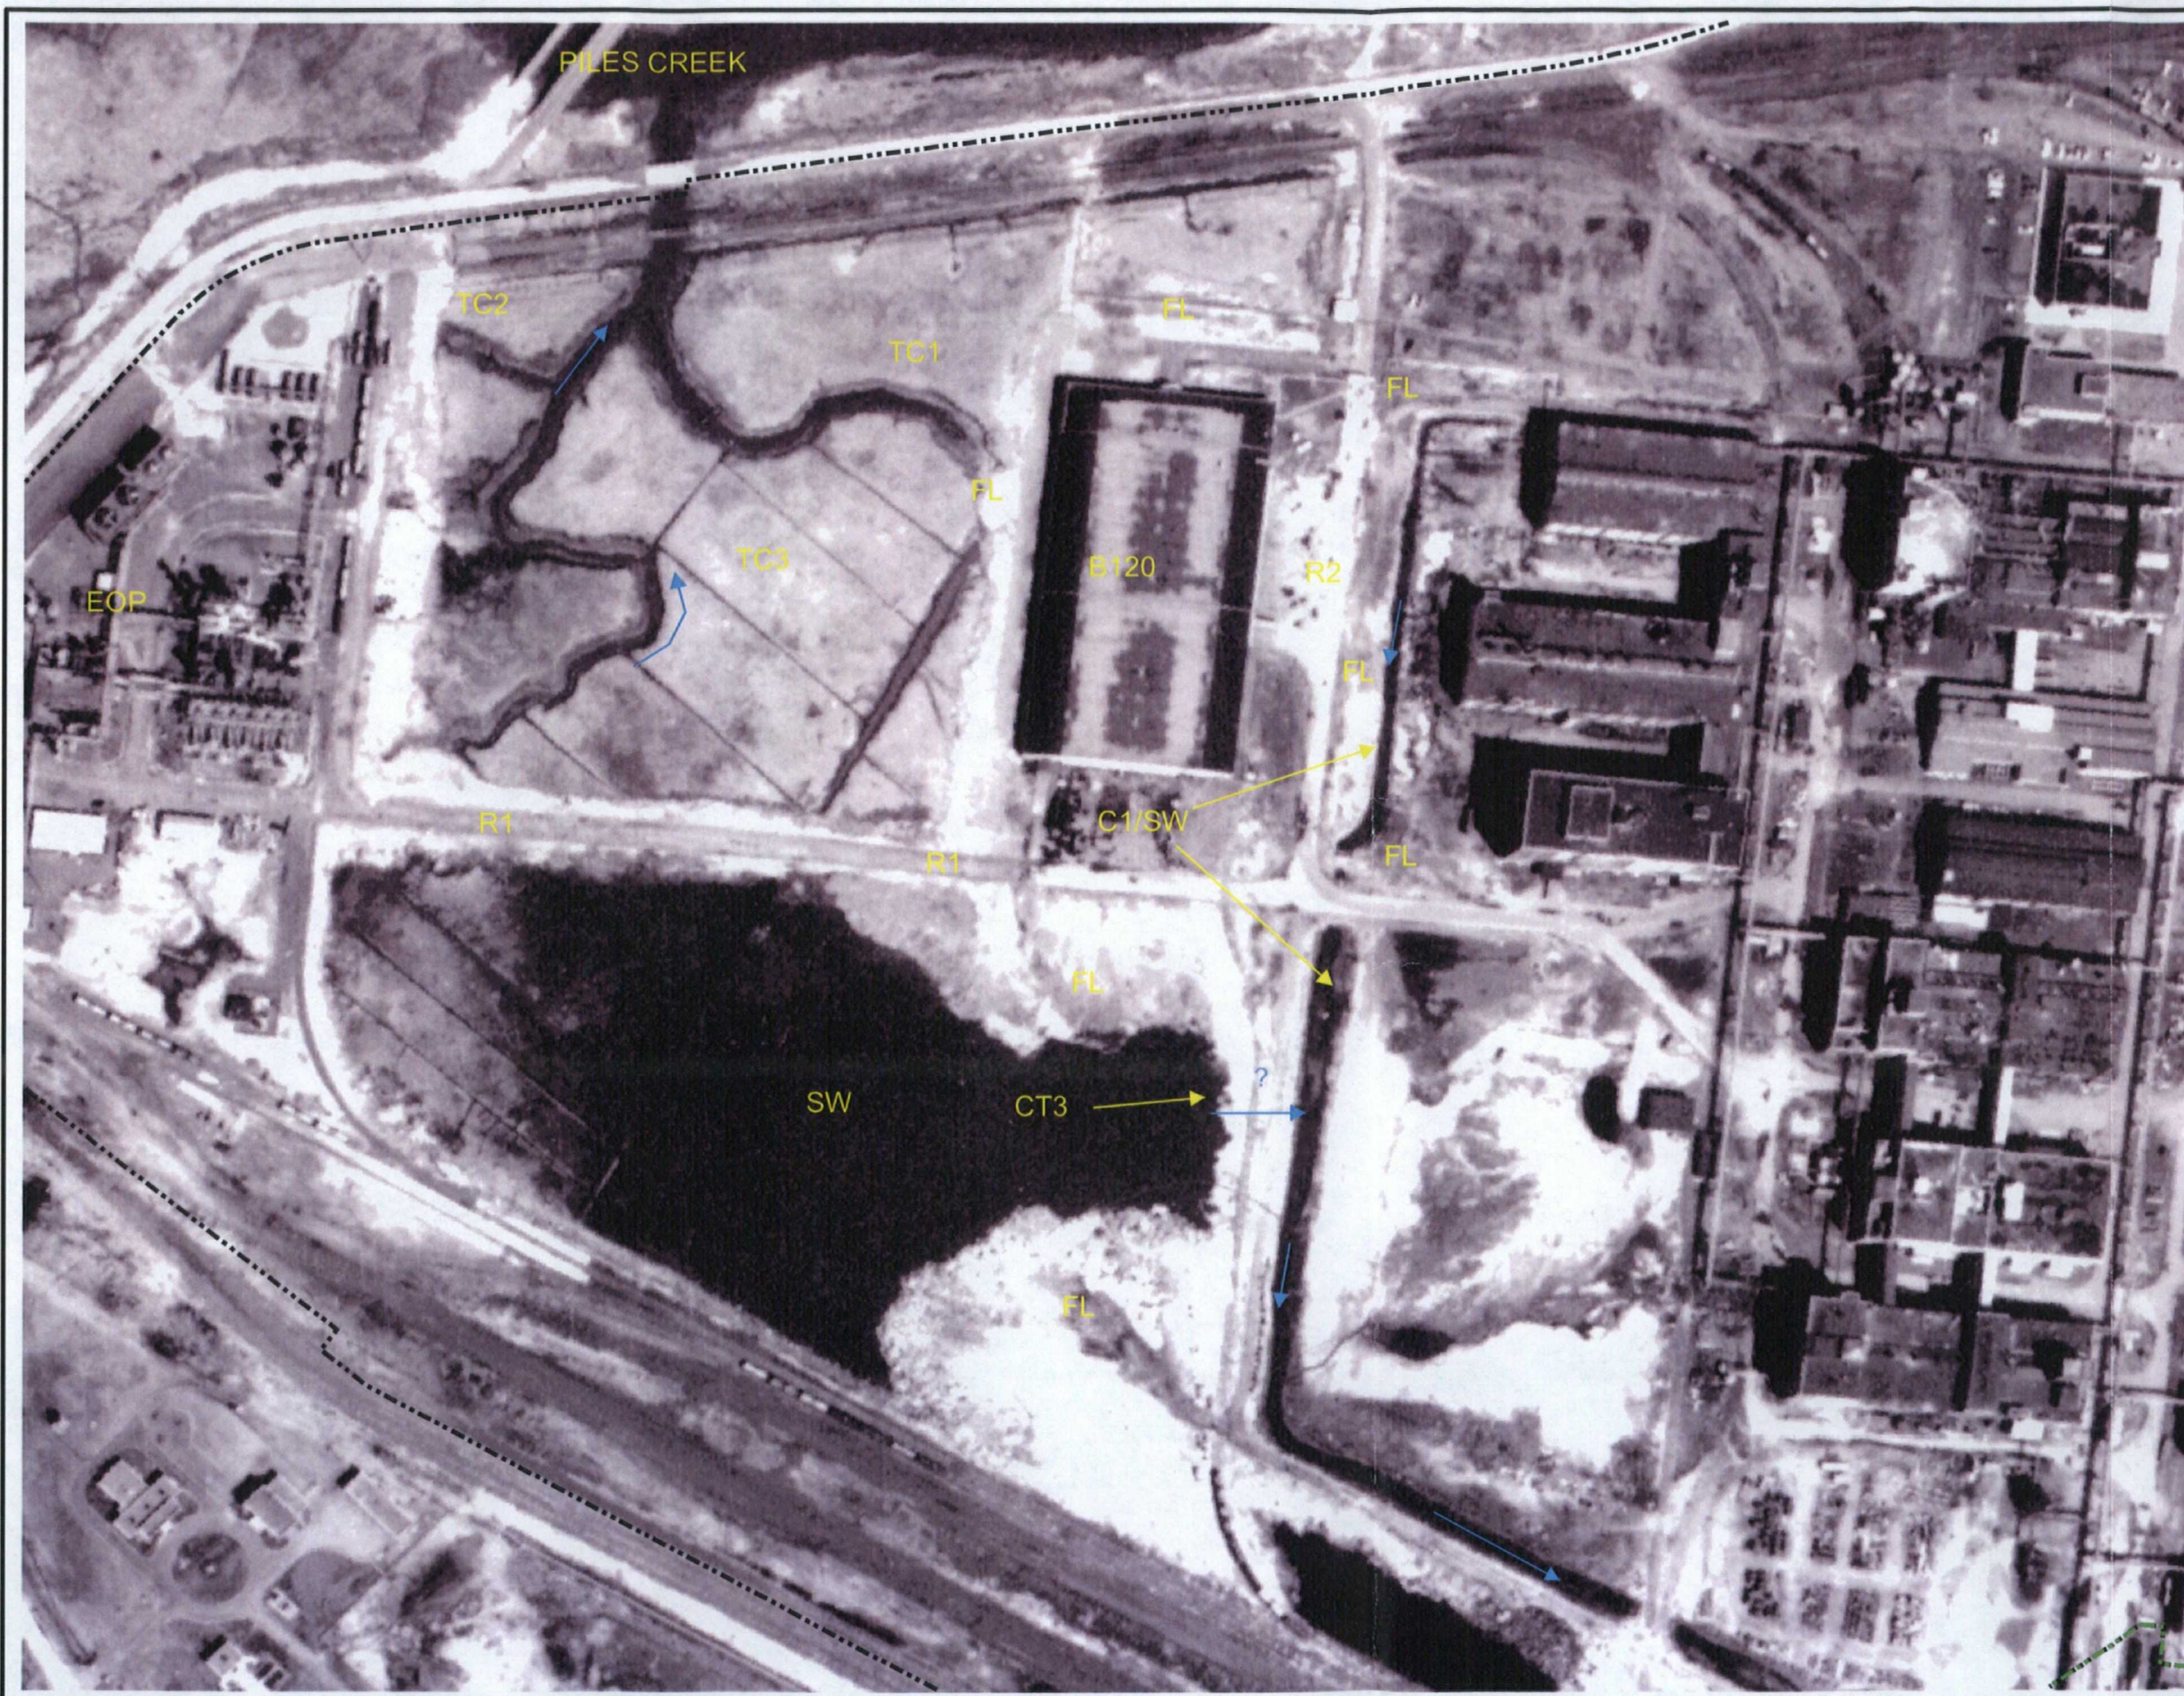
FIGURE 2-10
ISP LINDEN SITE
AND LCP SITE
APRIL 3, 1959
LCP Chemicals, Inc. Superfund Site
Linden, New Jersey

Each of the features described above on the close-up view is depicted on the large view map on Figure 2-10.

There are no noticeable differences in the LCP facility, channel C1, and South Branch Creek on the LCP site since April 3, 1959 (Figure 2-10).

The fill area (FL) located near the standing water observed on April 23, 1961, has expanded to almost completely fill this area. The standing water (SW) observed in the southern cell of the western marsh on April 23, 1961 (refer to Figure 2-10) is largely absent.

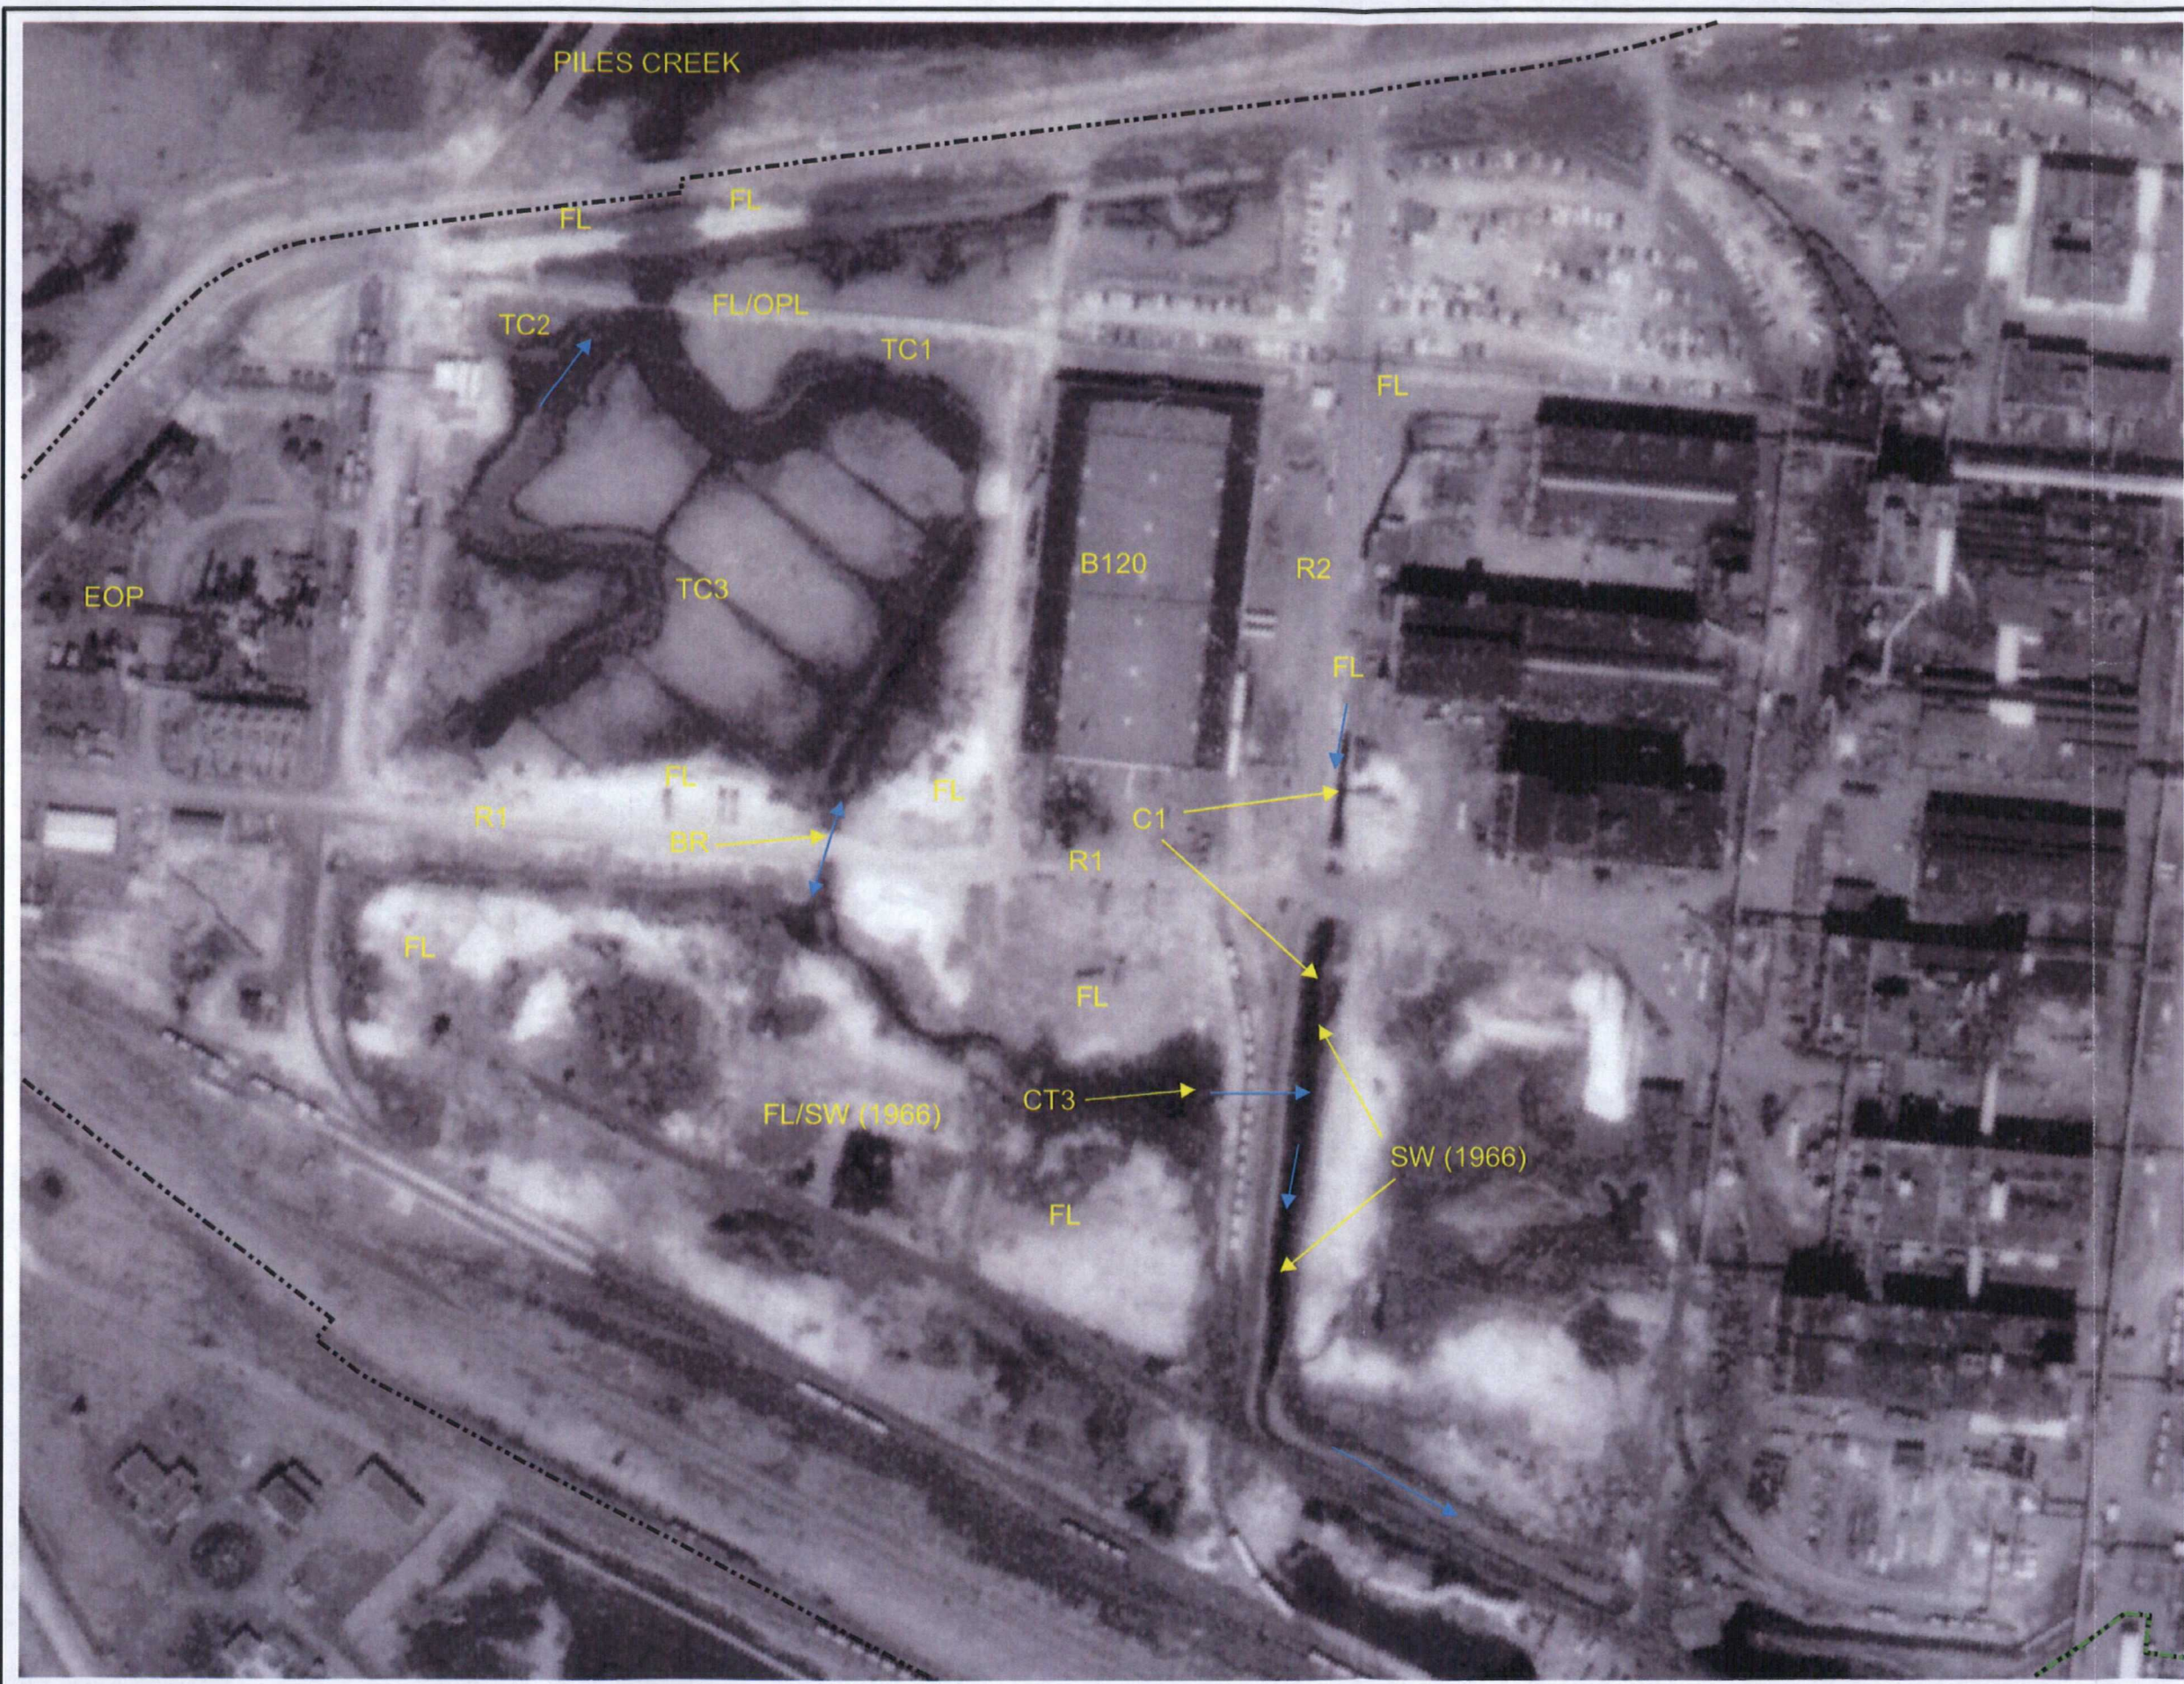
FIGURE 2-14
ISP LINDEN SITE
AND LCP SITE
DECEMBER 4, 1966
LCP Chemicals, Inc. Superfund Site
Linden, New Jersey

Each of the features described above on the close-up view is depicted on the large view map on Figure 2-14.

There are no noticeable differences in the LCP facility, channel C1, and South Branch Creek on the LCP site since December 4, 1966 (Figure 2-14).

After April 11, 1967 (refer to Figure 2-14), the construction of a dam has been completed between the tidal creek channels and Piles Creek. As a result of the dam, standing water (SW) is visible in the northern area of the marsh, indicating that this area no longer drains to the north to Piles Creek. In fact, the northern cell of the marsh has been completely flooded, eliminating the tidal creek channels previously visible. Water from these areas likely flows through culvert CT3 into channel C1.
